# **EPA R6 Dive Team Operations Report**

**San Jacinto Waste Pits  
Channelview, TX  
December 9-10, 2015**

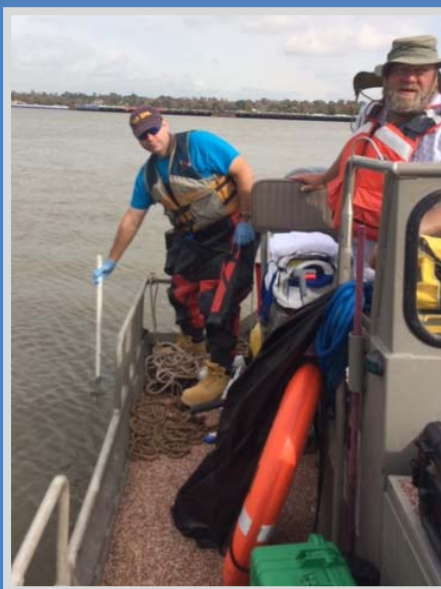
Location A.1 - On Wednesday, 12/9, the tethered diver entered the river at location A.1 on foot in an attempt to walk into deeper water. The diver was not able to walk because he sank into the silty bottom in the area immediately adjacent to the boat. Hard rock was not encountered at the river bottom in the immediate area of boat and diver. Diver was relocated to A.2 On Thursday, 12/10, the team returned back to this location to perform further investigation. In order to better define the area where rock was not present, a calibrated plastic pole (probe) operated from the boat was used to determine the presence/absence of rock at 4 GPS coordinates (see Map). Probe locations indicate the hole is at least 17 ft across.

After penetrating multiple feet into the sediment, the white plastic pole was covered with a thick, grey, sludge-like material when brought to the surface (Image 1, Image 2, and Image 3). This material is not similar in nature to the flocculent sediment identified at other areas of the cap.

**Image 1:**  
Insertion of probe adjacent to location A.1 where rock is not present.

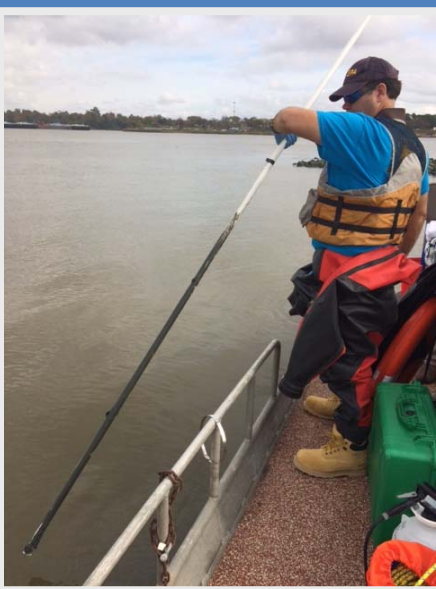
**Image 2:**  
Probe brought to the surface after sediment penetration adjacent to location A.1.

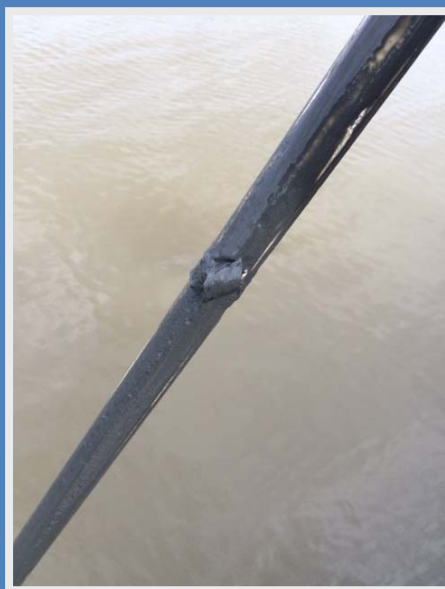
**Image 3:**  
Thick, grey, sludge-like material on probe after sediment penetration adjacent to A.1.

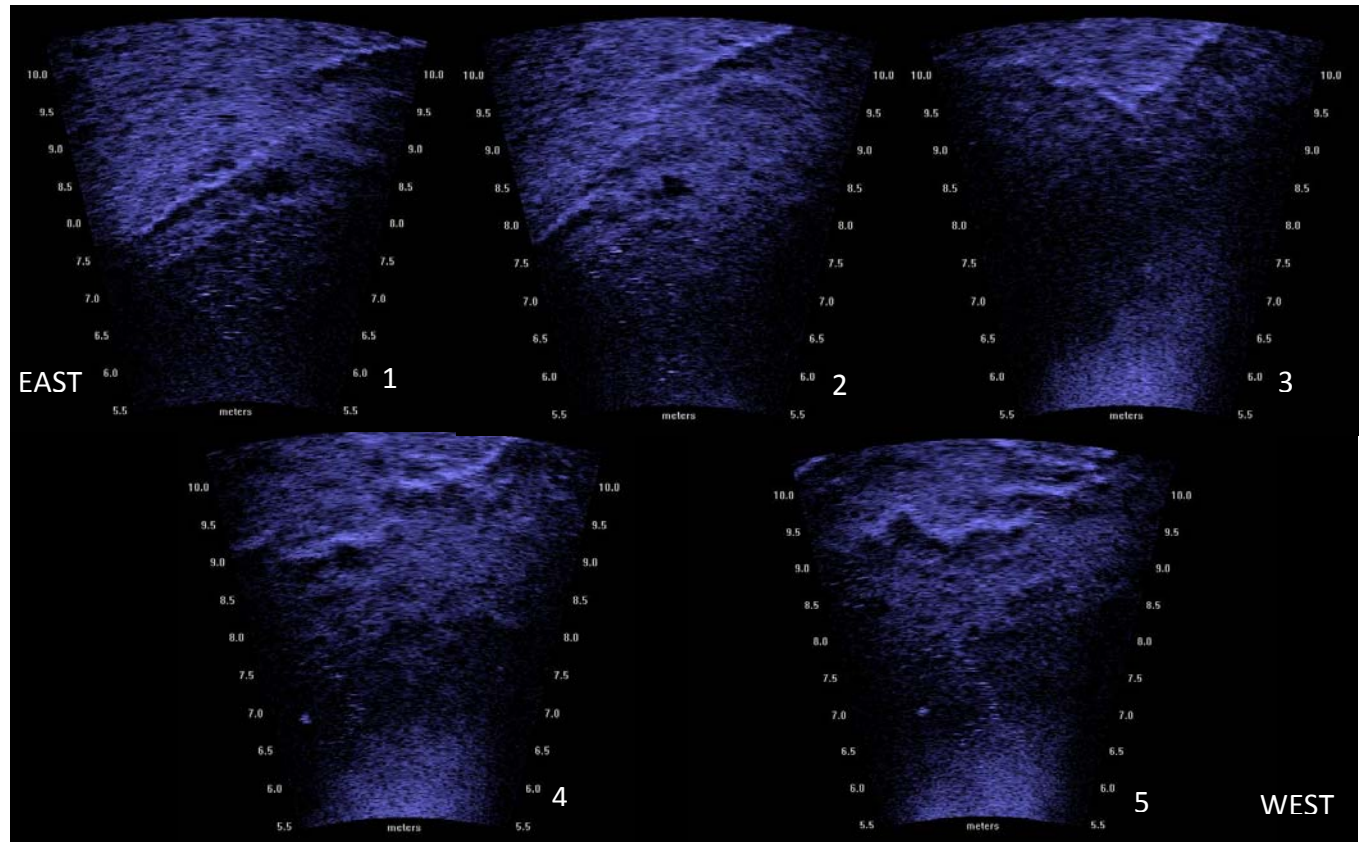
Imaging sonar was utilized in this area in an attempt to visualize the area of deficiency. This area was not identifiable via sonar, but other areas of interest were identified based on changes in color within the sonar image (Image 4 and Map). A tethered diver was used to physically inspect these areas. Rock was found to be present throughout these areas. Two factors introduced difficulty during sonar operation. Wind-driven movement of the boat distorted sonar imagery. Usefulness of the sonar was limited to areas that were covered with little to no sediment. This condition existed in areas of the cap with sloping bathymetry.

**Image 4:** Sonar Images of armored cap. Appearing in order from East to West and top of the image pointing South towards the shoreline.
